حولية الآثار اليمنية

العددان الثالث والرابع

The conservation of the new found inscription stone in the Almaqah temple Sirwah, March 2006.

Christian Weiss

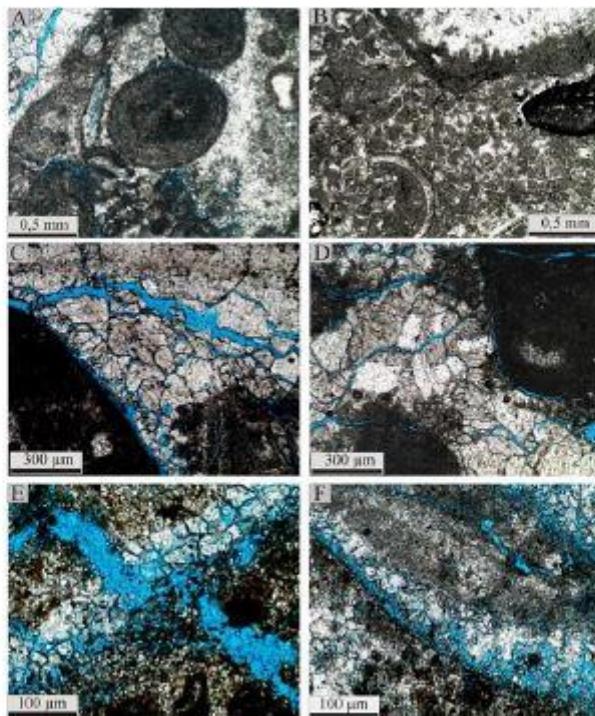
Fig. 2: Thin sections, the blue colour is pore space with a origin by stone destruction.

The stone is contaminated by salt. Three samples were taken shortly after the excavation. The salts are chloride and nitrate, the amount of nitrate is significantly higher than the chloride, a sign for the source from the sediment load. The highest amount of salt was in the backside of the stone. Thin sections from the backside of the stone show that the substance is heavily damaged, fractures among single stone components are open and partly they are soluted. This means that the stone will be destroyed by a long-time contact with rain, which allows water to penetrate the open pores and to destabilise the substance.

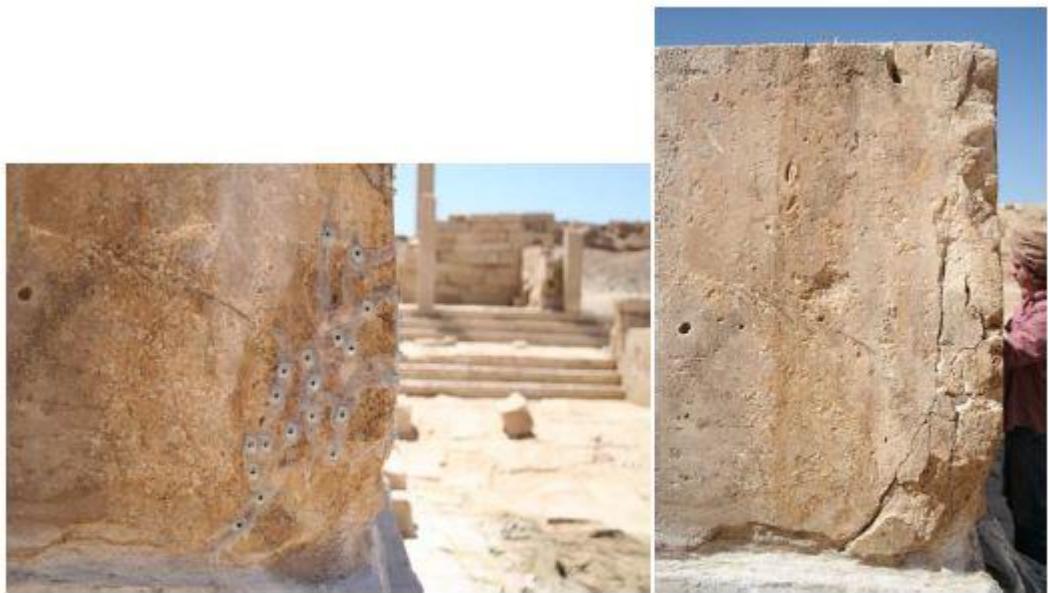
Fig 3: Left: Eastern side of the stone with fissures covered by hot glue. Right: the fissures after fillings with epoxy resin.

The technique of fissure fillings is to close the whole fissure by hot glue. Before the stone was prepared with a so called primer, a solution which prevent a contact between the stone surface and the hot glue. Than the fissures were closed by hot glue with few injection channels connected by the fissures. The epoxy resin is injected by injection syrons with low pressure. After 24 h the hot glue becomes removed and the stone is cleaned. After that the upper part of the fissure is closed by the sloping mortar.

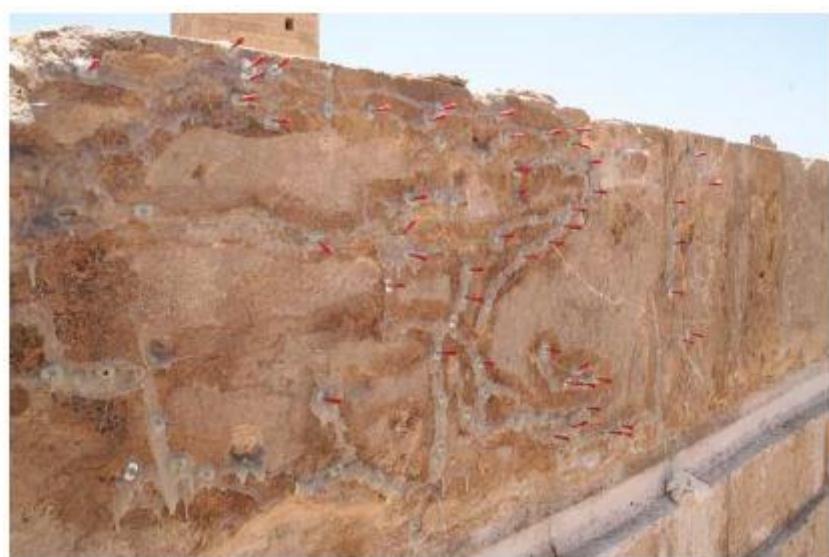
Fig. 4: The large lose part in the middles of the stone covered by hot glue. The injection channels are closed by red caps.

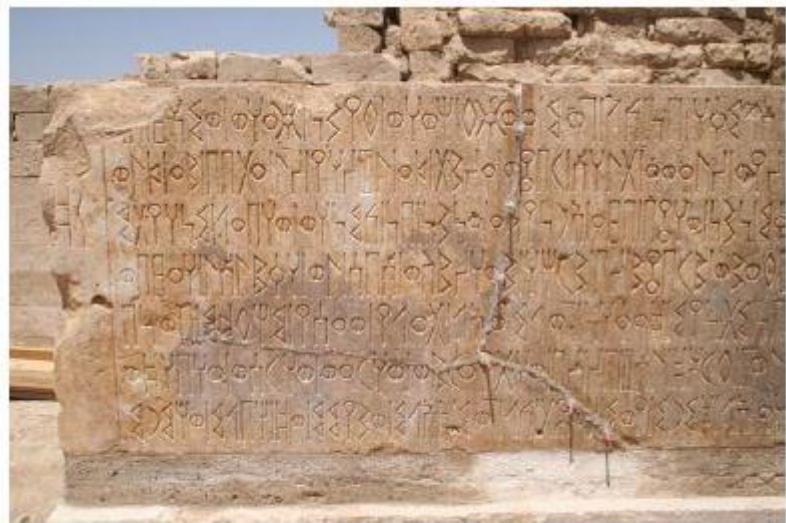
Fig. 5: The closed fissure on the western front side of the stone.

Fissures with a small extension were filled by a high viscous epoxy resin. This resin enables the filling of fractures up to 0,3 mm. This allows the stabilisation of the stone structure in large parts.

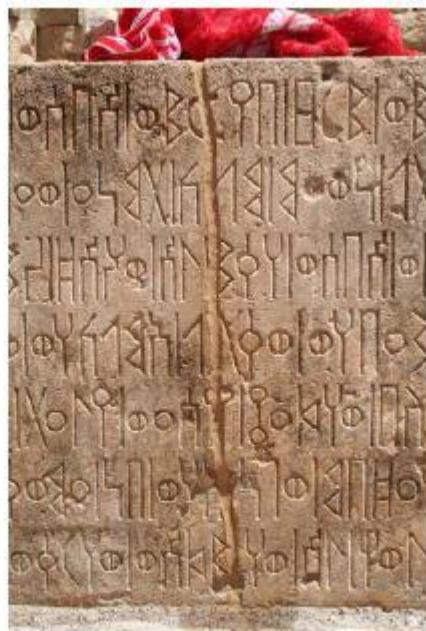
Fig. 5: The large fissure on the front site of the stone with the filling made of lime mortar.

The large fissure in the middle part was filled with a lime whitewash consisting of slake lime and fine grained well sorted sand dispersed in water. This method allows the filling of high volume fissures. The use of epoxy resins is not necessary in the sense that no static function is influenced and there is no danger of material loss by back weathering. On the front and the back side the fissure was closed by the coloured lime mortar and the white wash was filled inside from the topside. The volume of whitewash was about 12 l.

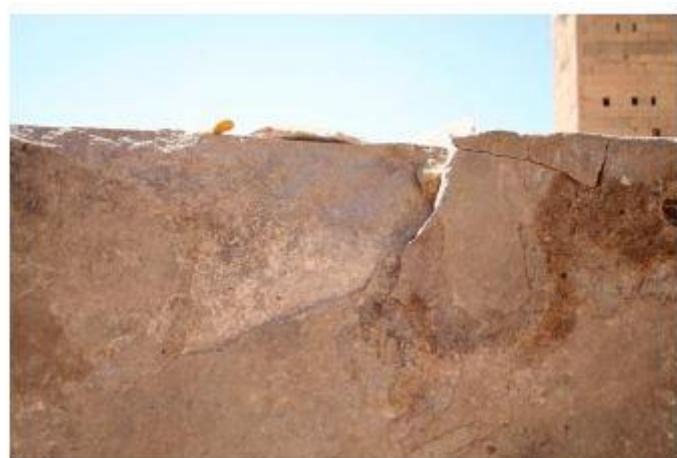
Fig. 6: Area with heavy material lose on the western back side.

During the transportation by the re-erection several parts of the stone were lost. Those lost parts were collected and could reinstalled. The first step was the cleaning of the surface by hand. The single parts were adapted to the place on the stone and fixed with the described epoxy-resin, with very low viscosity. After 24 h the fissures between the broken pieces and the stone were filled by the sloping lime mortar.

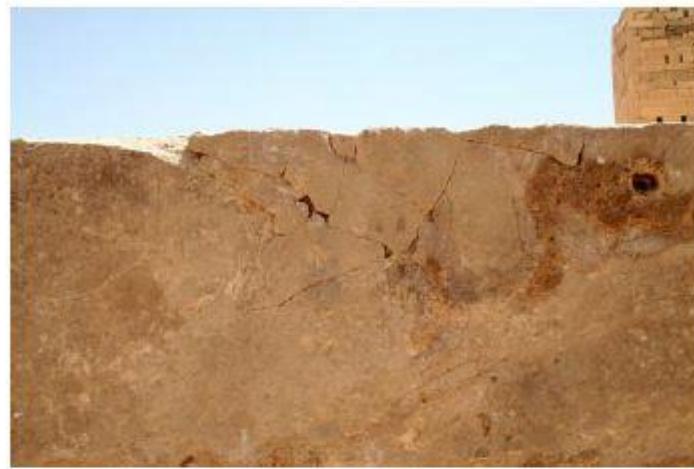
Fig. 7: The stone with the new installed broken pieces. The fissures between them and the stones are free.

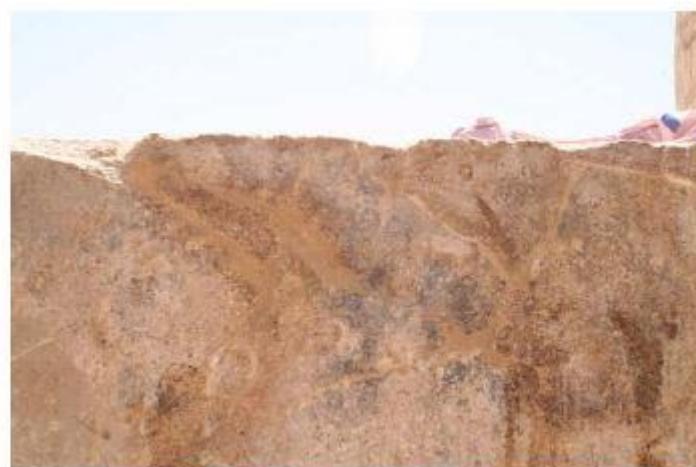
Fig. 8: The pieces with the filling of sloping mortar.
